Solar Alpha Rotary Joint Anomaly: The Materials & Processes Perspective

Aging Aircraft 2009

May 5th, 2009

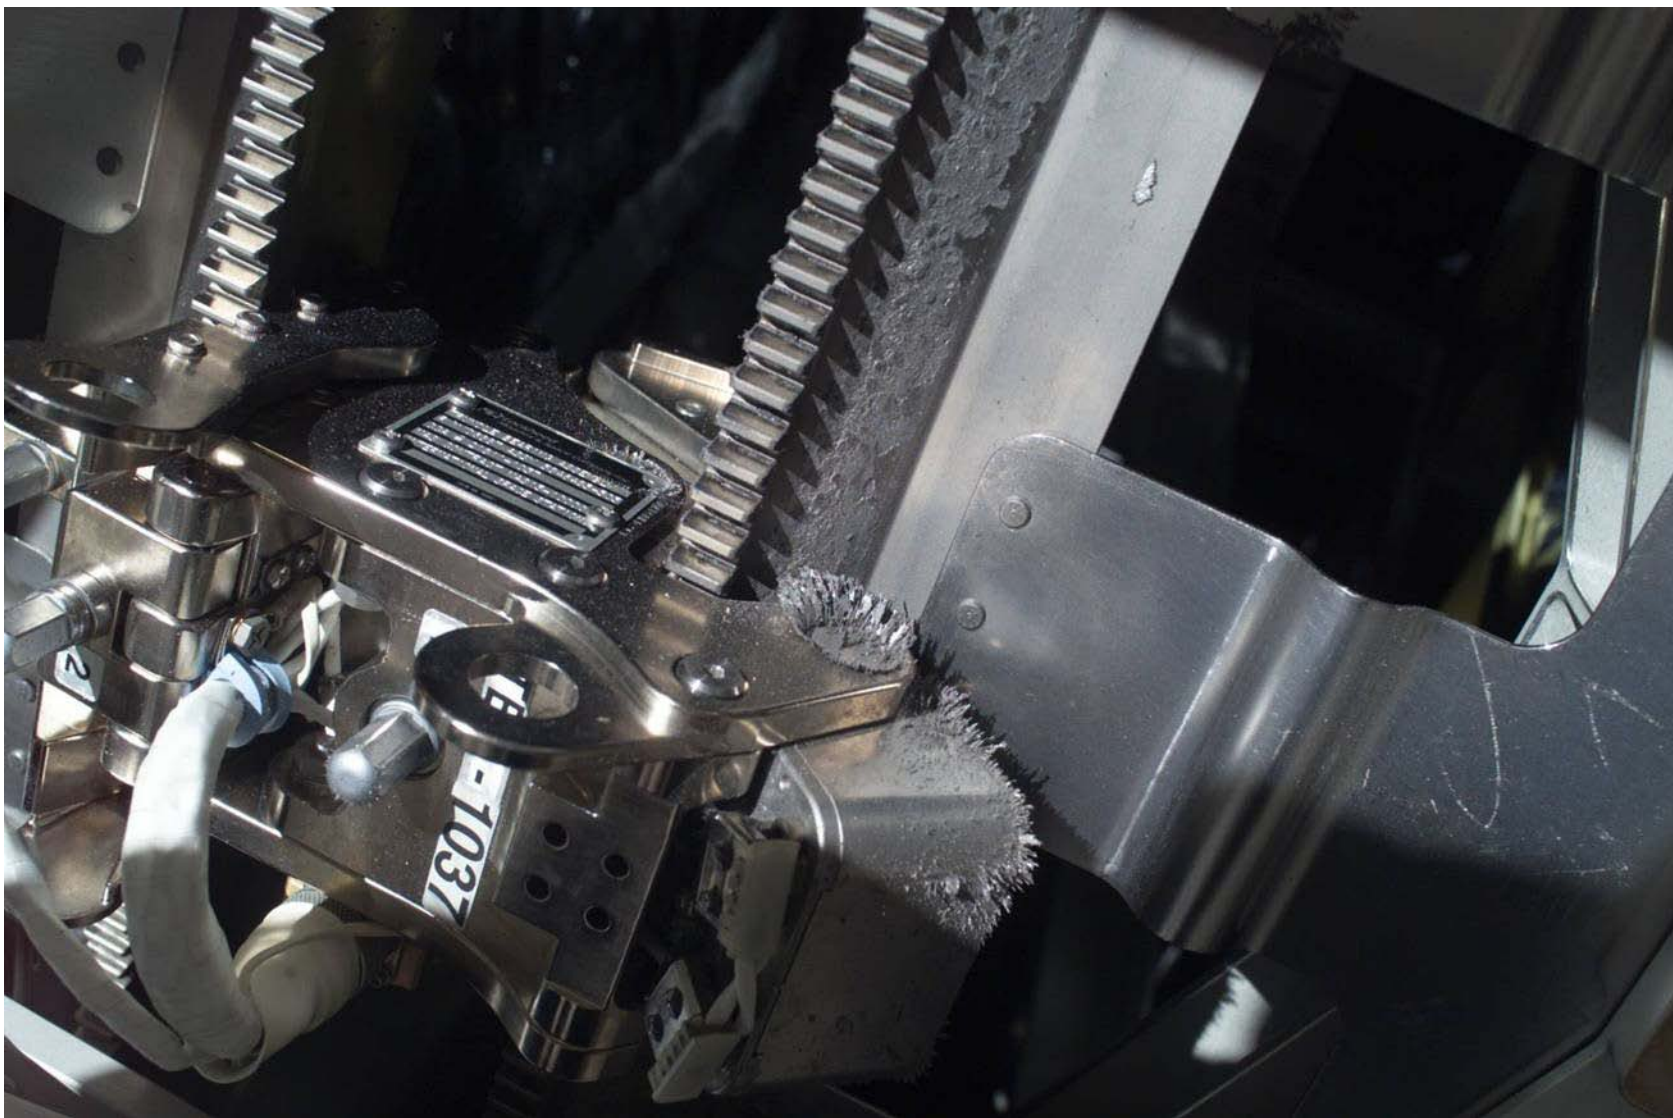
Starboard SARJ – Metallic Debris

- **Anomalous telemetry and noticeable vibrations prompted a visual inspection of the SARJ mechanism.**
- **Metallic debris was observed throughout the vicinity of the mechanism, including on the surface of the race ring.**
 - **Debris exhibited slight magnetic effects, aligning with available magnetic fields.**
- **Samples were taken via tape-lift from starboard SARJ. Multiple accessible surfaces were sampled including the area of rolling contact.**
- **One of the Trundle Bearing Assemblies (TBAs) was returned to ground for examination.**
 - **Samples were taken from all rollers, the housing and packaging of the TBA.**
- **Nitride control coupons and maskant interface coupons from the original nitriding process were retrieved and used for metallographic analysis.**

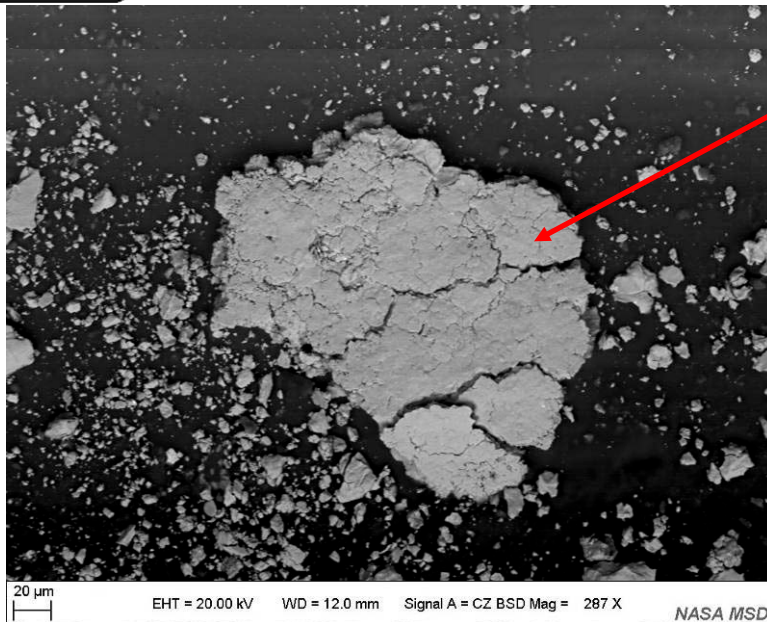
Agglomeration.

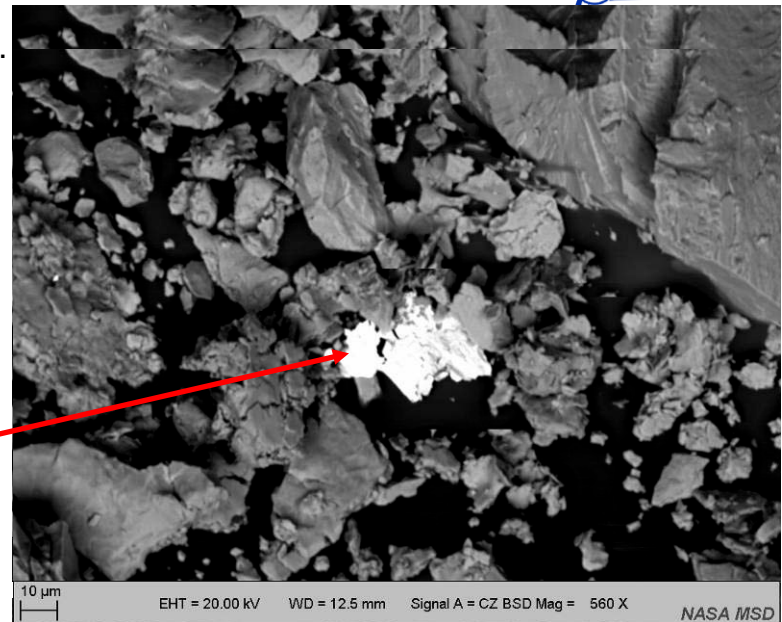
Gold particle
showing
atomic
contrast.

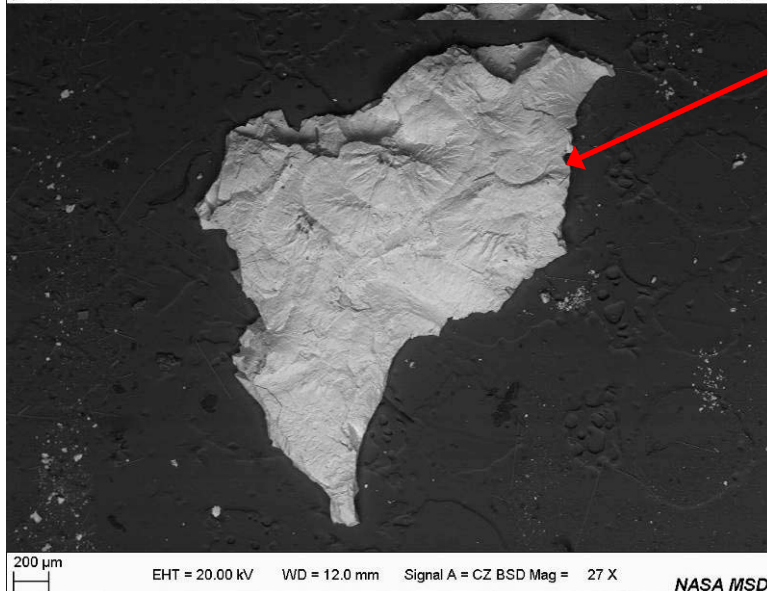
Evidence of
crack arrest
lines.

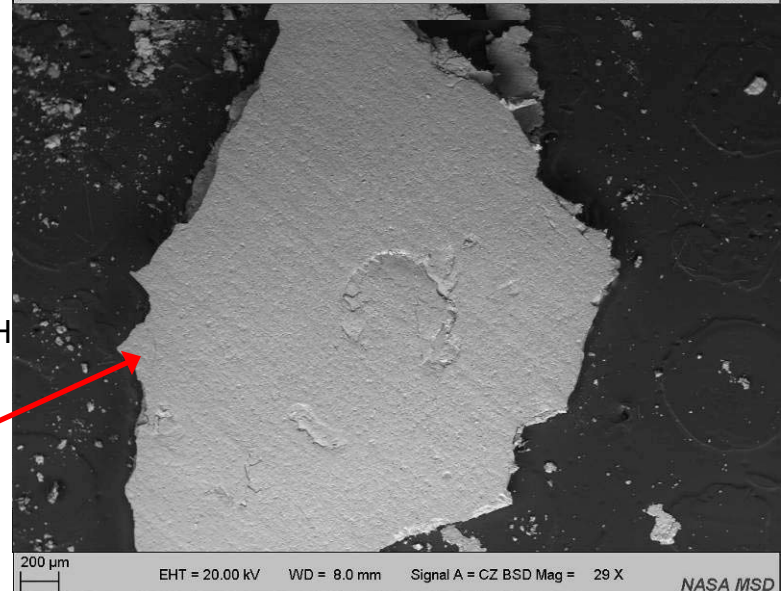
Original 15-5 PH
nitrided surface
with machine
markings.

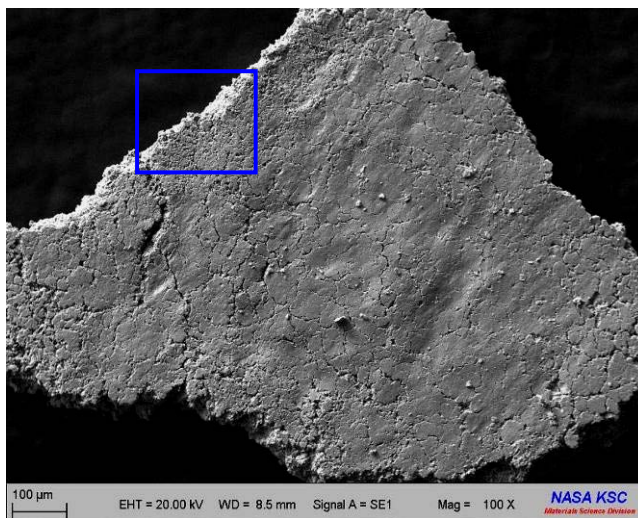
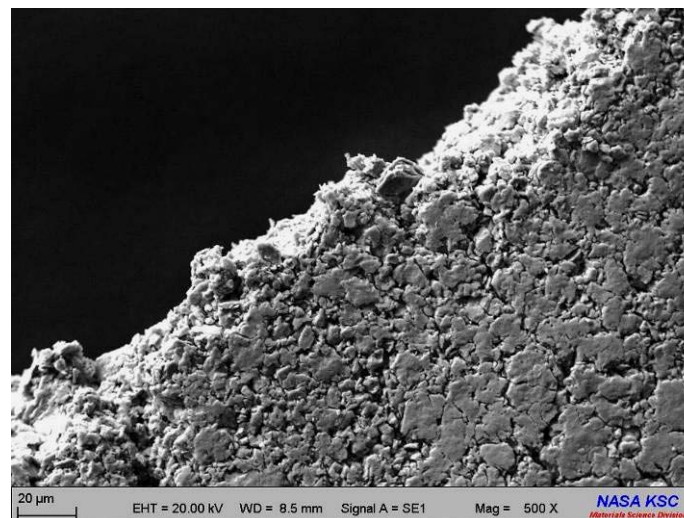
- Friable large particles are actually agglomerations of small particles

Nitrided 15-5 PH agglomerated fragment from Tape Sample 31
imaged under high vacuum.
Reference magnifications: 100X (left), 500X (right)

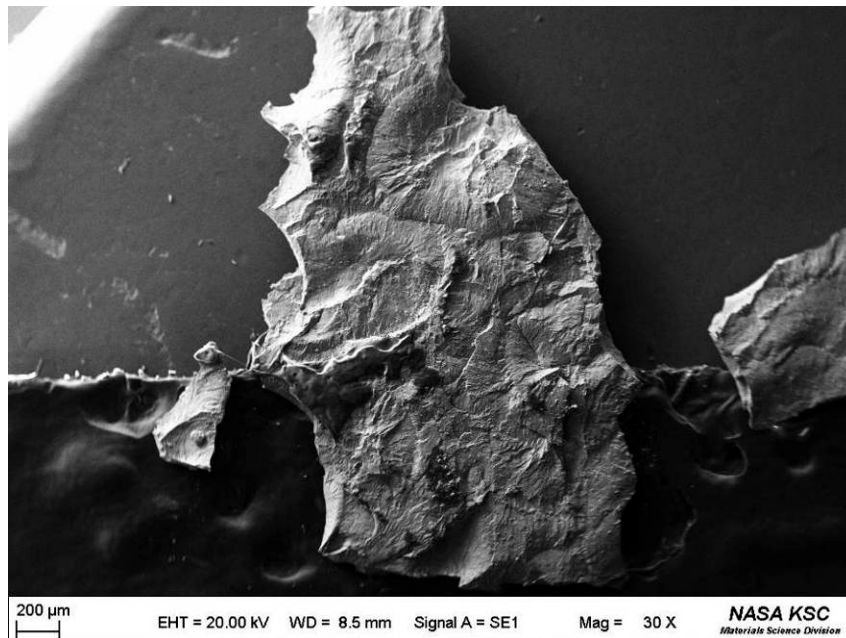
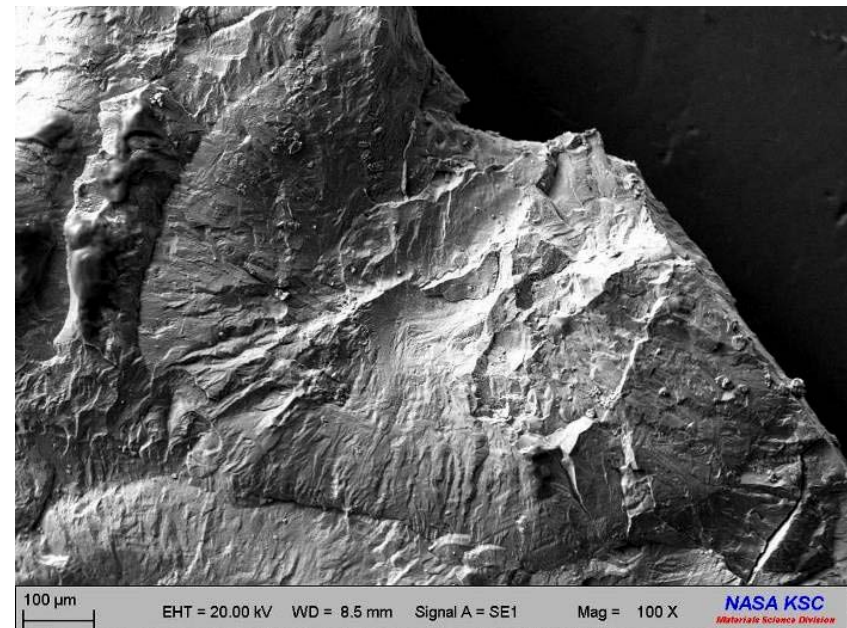
- Chip-Type fragments often exhibit crack initiation and arrest features
- Multiple initiation sites indicate a system-wide condition

Nitrided 15-5 PH Chip-Type fragment from Tape Sample 31 imaged under high vacuum showing fracture surface and crack initiation/arrest features. Reference magnifications: 30X (left), 100X (right)

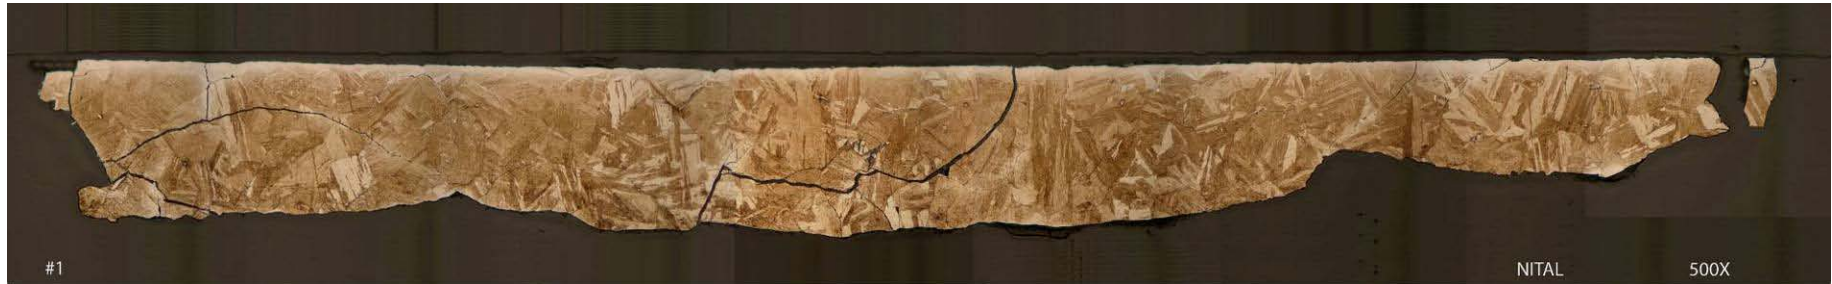
Crack Propagation in Larger Flakes

Nitrided 15-5 PH Chip-Type fragment from Tape Sample 31
imaged in cross section, showing original surface (with residual
white layer) and transgranular fracture surface after 2% Nital etch

- **When viewed in cross-section, the propagation path does not appear to preferentially follow areas of intergranular networking**
- **Cracking is transgranular**

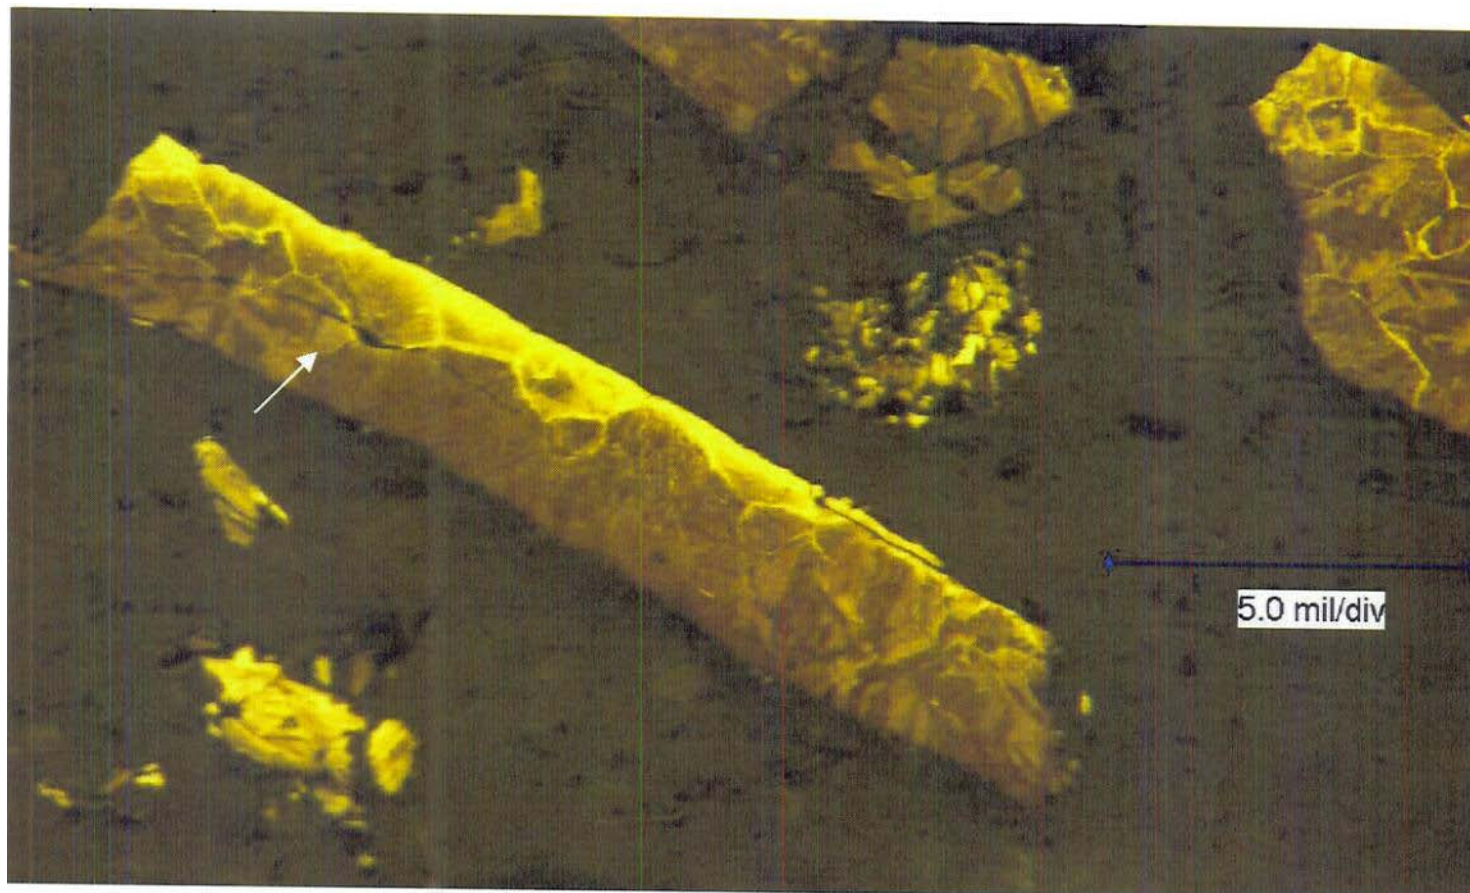
Chip-Type Debris

White layer is present in many locations, it was not removed by the 320 grit garnet blasting operation (post-nitriding) in many locations. The visual cue for post-nitride grit blast was a bright surface; this blasting process removed the dark oxide scale (from the gas nitride activation process) but not all of the white layer.

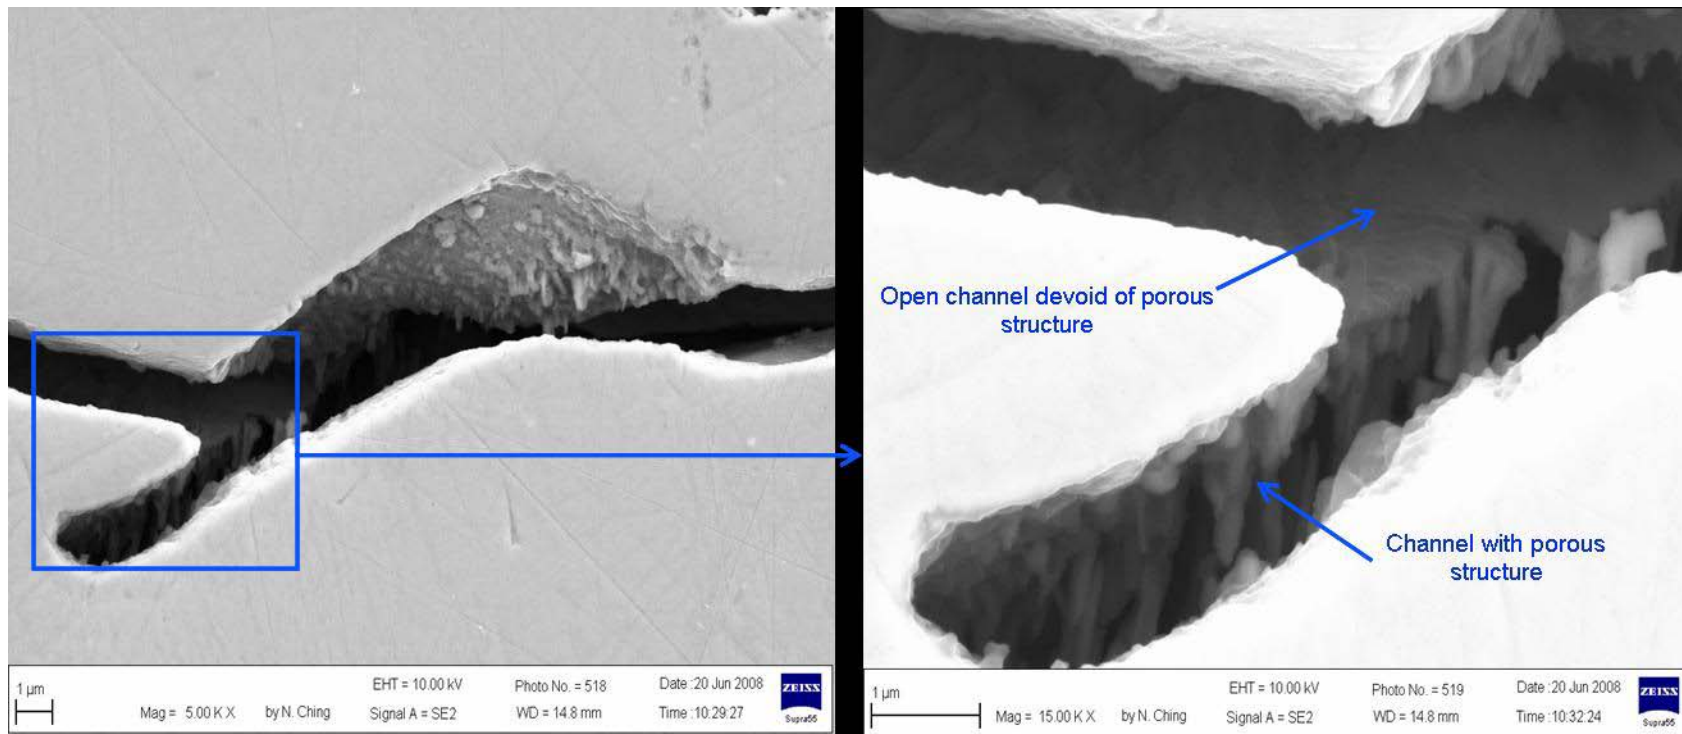
DIGS in Nitrided Rolling Test Coupon

Sectioned and polished nitrided rolling test coupon. Branching of DIGS with different degree of porosity in each branch. Upper branch has a smooth surface and forms a single void while lower branch has a rough surface suggesting the existence of an earlier porous structure.

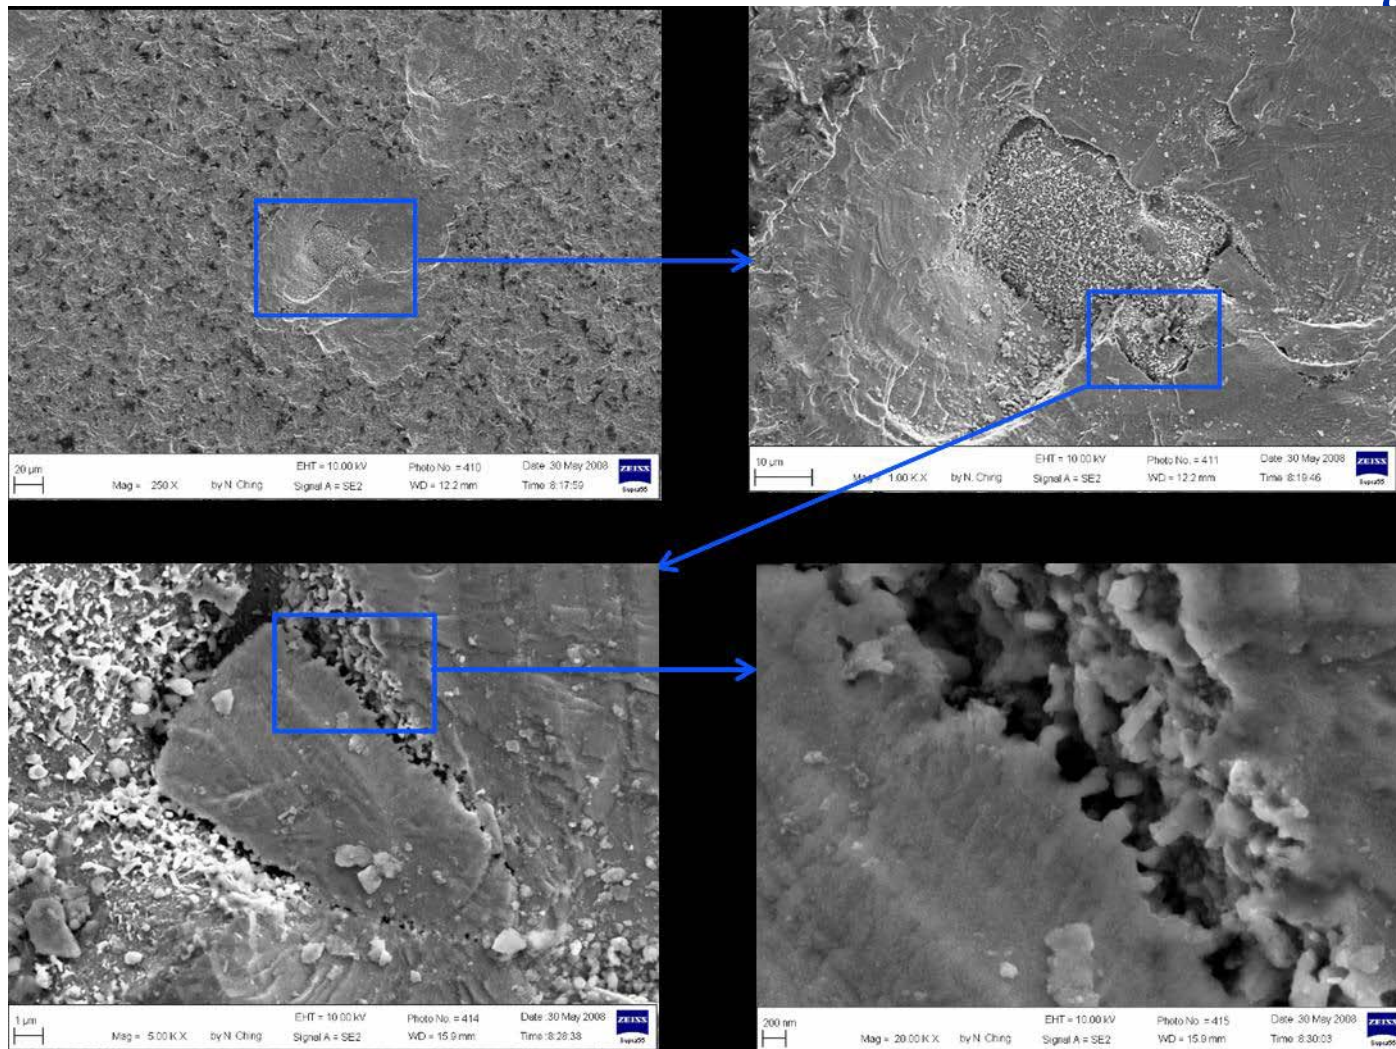
DIGS in Nitrided Rolling Test Coupon

Progressively increased magnification illustrating the porous nature of DIGS in nitride test coupon.

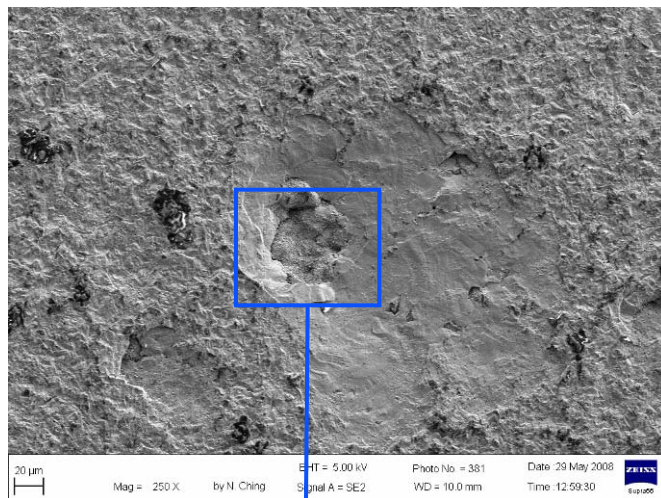
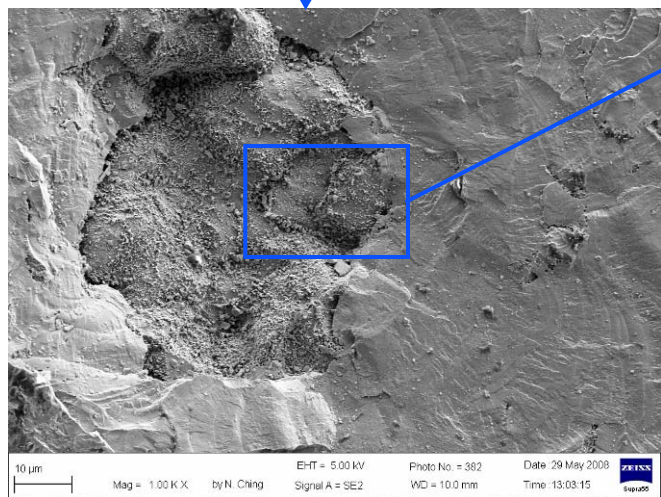
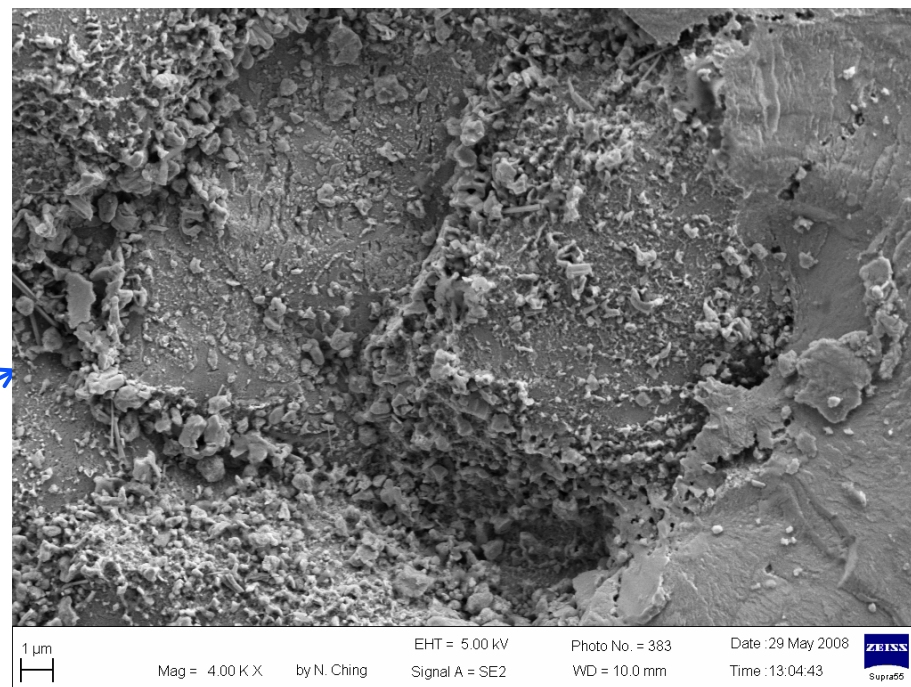
DIGS in Nitrided Rolling Test Coupon

Spalls created during the rolling test are associated with DIGS. Cracks originate in DIGS and propagate radially to form spalls.

Fragmented DIGS porous structure is shown as debris

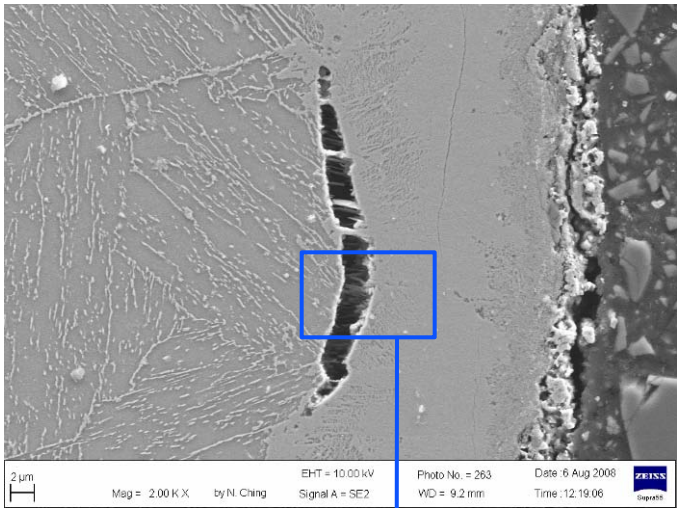
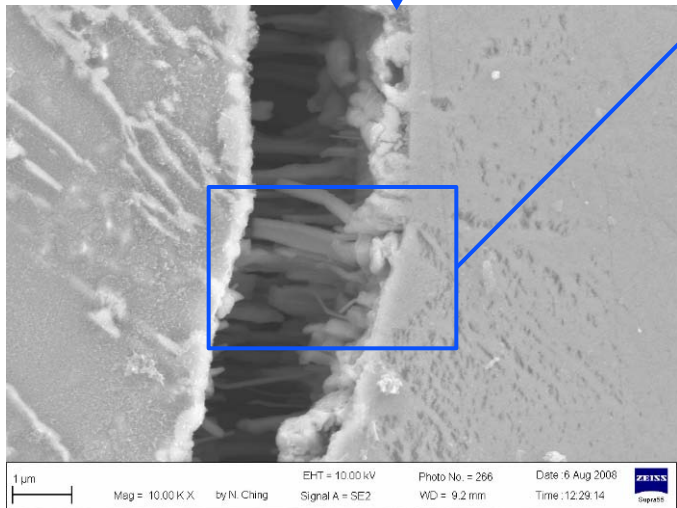
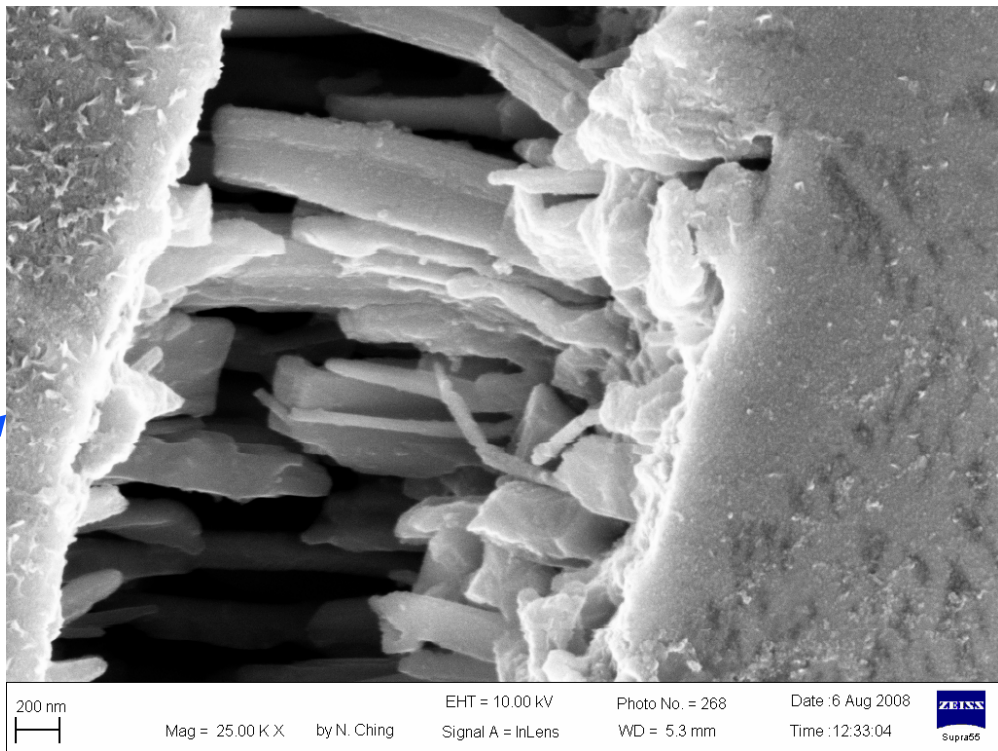
DIGS in Nitride Control Witness Coupon

Polished metallographic sample exhibiting DIGS.
The degree of porosity and the type scaffolding structure remaining inside each DIGS varies and at times appears as a nanostructure.

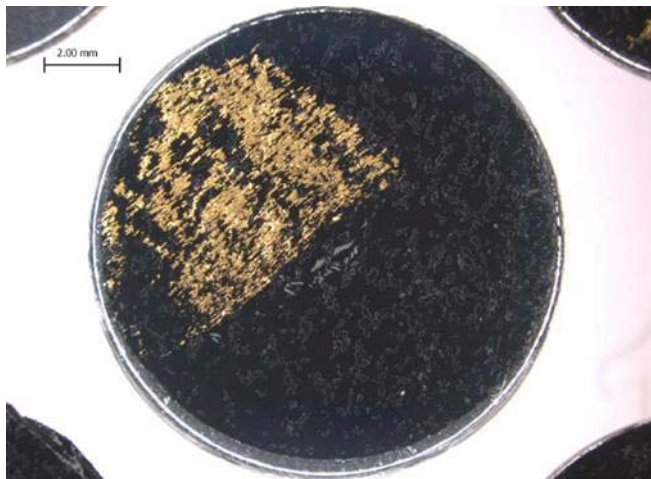
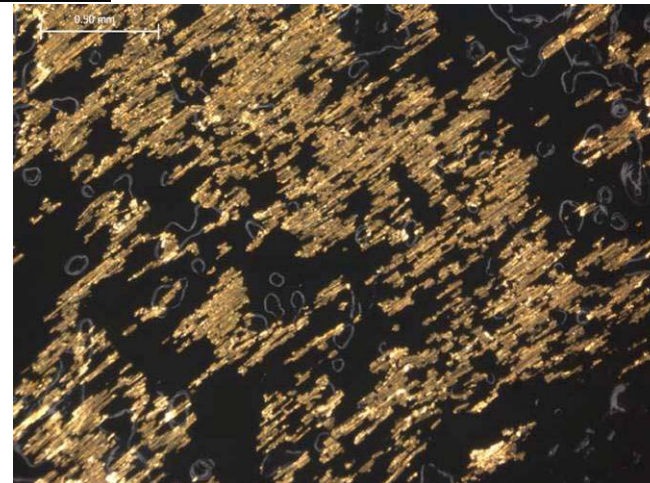
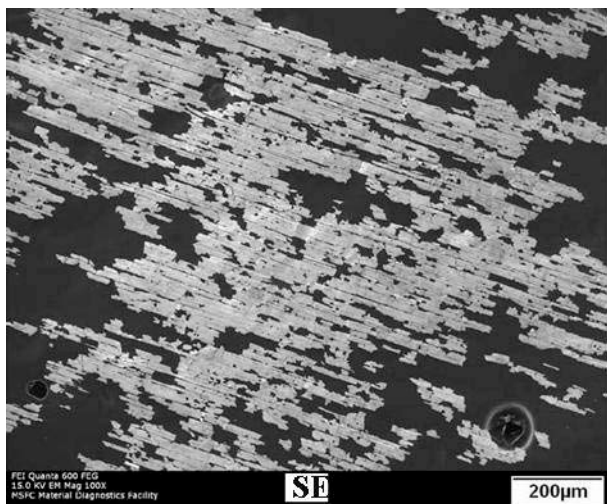
TBA 1045, Datum A, Test #2, Carbon Tape

- Gold removed from TBA 1045 was segmented into strips, typical for all TBA roller tape tests with gold adhesion failures.

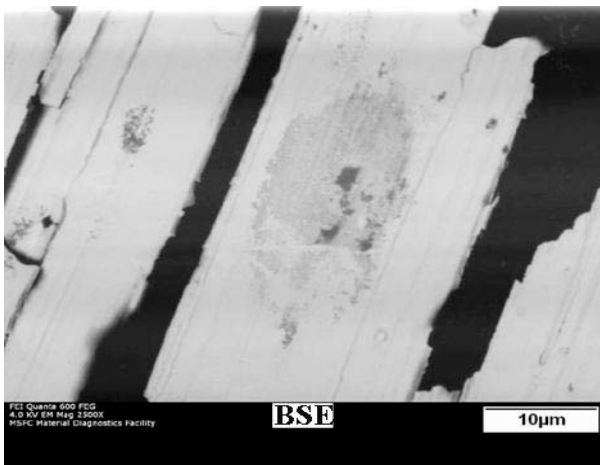
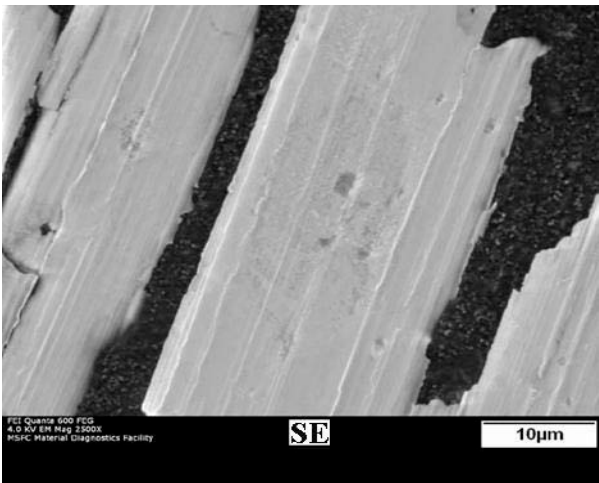
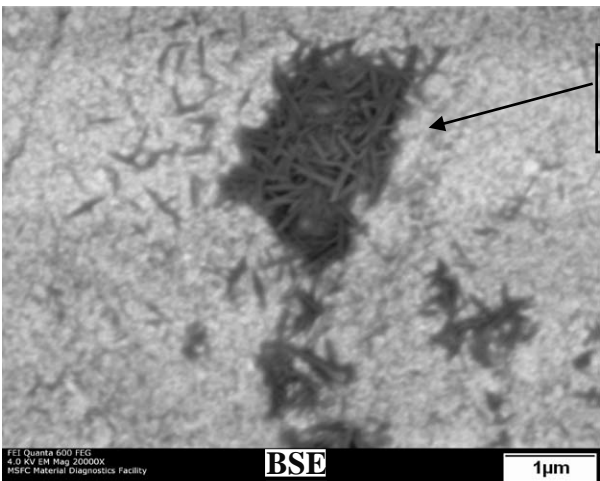
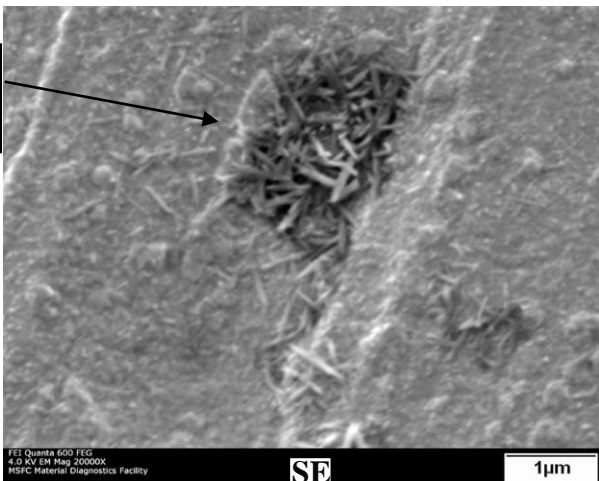
TBA 1005, Outer 45, Test #1, SEM

Iron Oxide (by
elemental analysis)

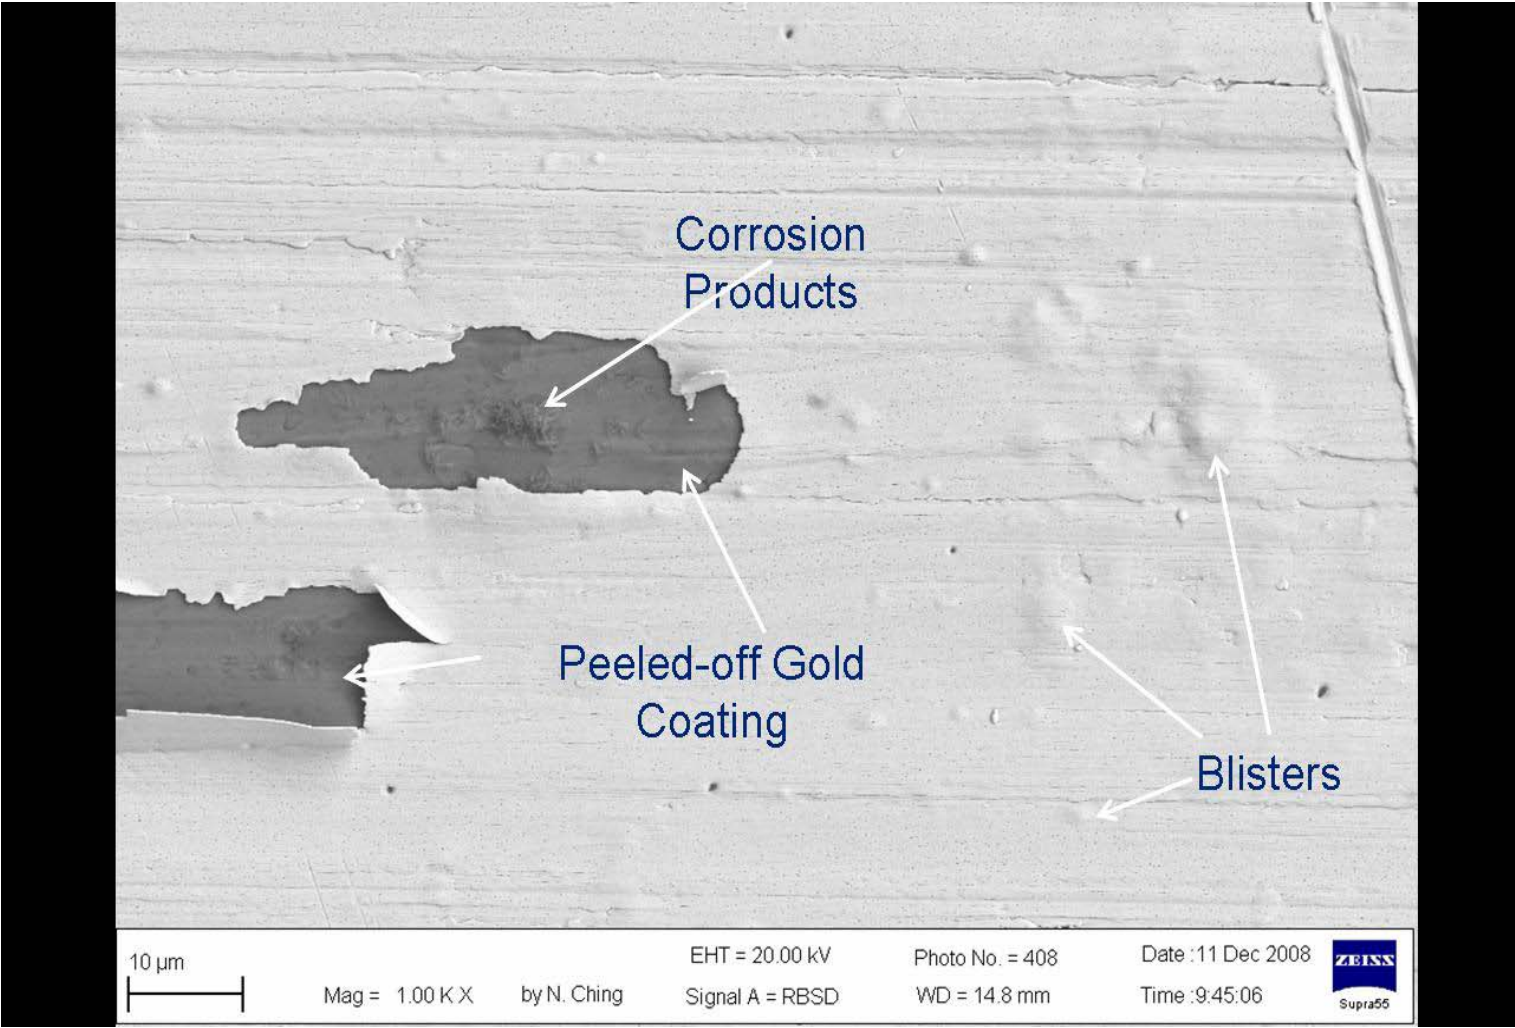
B-1 After 4th Aging Stage, 1st Intersection

- **After seven more days of accelerated testing (21 days total), gold adhesion loss was widespread and very similar to tape test results from the flight spares**

- **Comparable area of iron oxide corrosion observed, undercutting adhesion between gold coating and substrate**

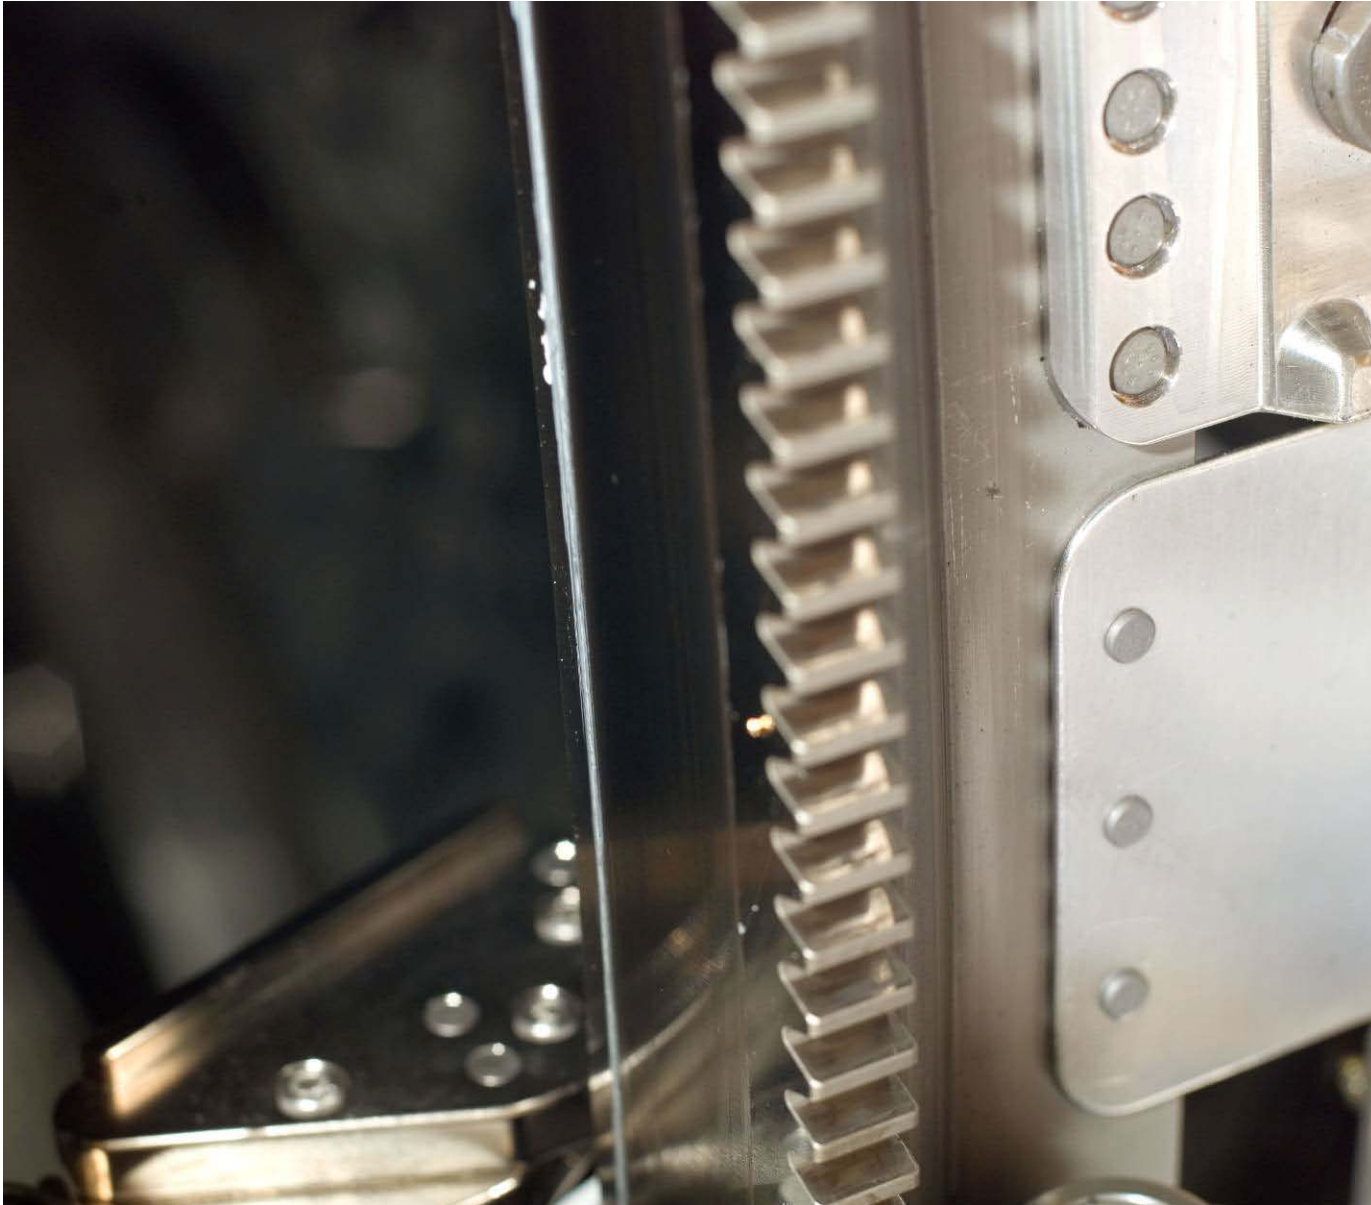
Port SARJ - Evidence of Unintentional Grease

- **Port SARJ has not displayed anomalous behavior to date, an inspection was conducted to assess the status of the race ring surface**
 - **Did not observe any obvious visible damage**
- **Inspection indicated the presence of a continuous streak of white substance along one edge – determined to be Braycote 601, which is used elsewhere in the mechanism**
- **A small number of tape-lift samples were taken from the non-rolling contact surface**
 - **Debris collected consisted of ~30% 15-5PH, ~70% 440C, and a small amount of gold particulate.**
 - **Composition of debris is consistent with expected wear of the SARJ mechanism, based on comparison with residual debris from hardware qualification tests**
